Section III

Existing Conditions of Ecological Resources

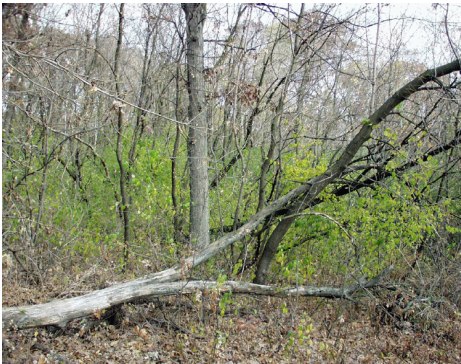
Recently Developed Forest in Degraded Condition: These systems are comprised of the early invading species such as cottonwood, box elder, green ash and red elm. These areas typically occupy fallow fields, former wetland soils that had been drained and fallowed from agricultural land uses for 20-50 years, spoil piles along ditches/creeks/dikes, and wetland and pond margins where successional tree species have invaded and caused shade suppression of the native, soil-stabilizing vegetation. In almost all cases where the early successional forest trees have developed, the ground cover vegetation system has collapsed and is represented by only a few shade tolerant species. Often the canopy, which is usually closed, includes dense growths of European buckthorn and other shrubs that are semi- to completely shade tolerant. The influence of shading by young trees and buckthorn has contributed to the decline of the native, soil-stabilizing vegetation. These are typically depauperate (stunted), low diversity, unstable systems, whereby many of the early successional species found there have short life spans and are beginning to show major senescence or mortality, particularly red and Siberian elm and boxelder. Where this vegetation occurs along the streams or wetlands it will contribute substantial woody debris to the adjacent aquatic systems, which contributes to bank erosion, log jams on water bodies at outlet structures, and other aquatic maintenance issues that are costly and preventable.

Recently developed forest in degraded condition is commonly found in the park. As shown, buckthorn is taking over the understory.

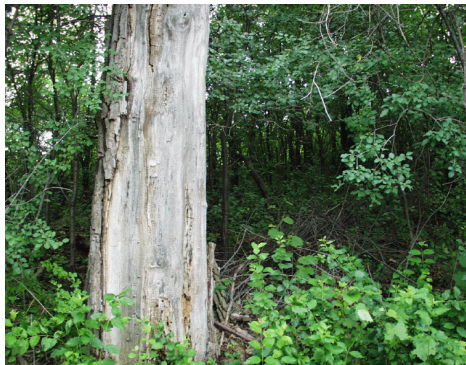
Lacking management, the mature oak savanna systems are being replaced by a dense understory of shrubs and trees.

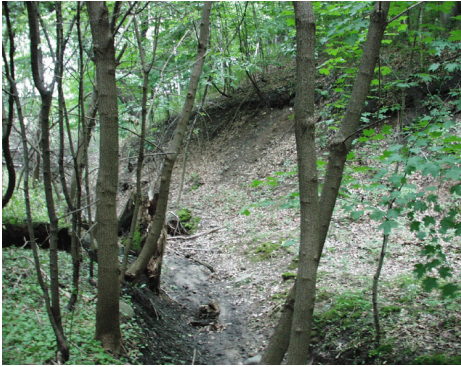
The lack of a vibrant groundcover in the mesic deciduous forest results in severe washouts and gullies, which leads to sedimentation of downstream lakes and ponds.

European buckthorn and other aggressive species have invaded portions of this mesic forest, resulting in areas of shade suppression.

European buckthorn and other aggressive species have invaded portions of this mesic forest, resulting in areas of shade suppression. This phenomenon results in reduced ground cover vegetation and limits the potential for native plants to compete with invading species. Lack of healthy ground cover vegetation in conjunction with the moderate to steep slopes in this portion of the park leaves these areas subject to severe erosion. This erosion not only exposes root systems and removes native seeds and other propagules, but also results in down slope deposition, which may either smother native upland soils or cause sedimentation in lakes, ponds, and wetlands.

Through a well thought-out restoration and management plan, many of these forest systems can be restored to represent more closely their pre-disturbance condition.

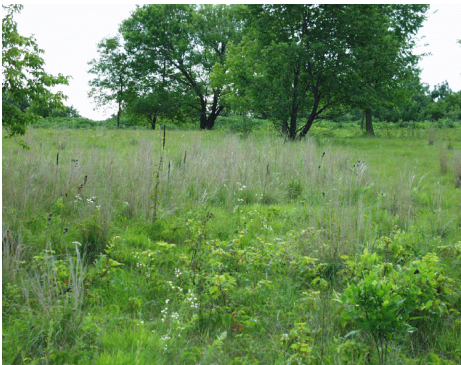
Management of the prairie systems is needed to forestall the invasion of less desirable species, such as the Siberian elm trees in the background.

The prairie remnant adjacent to the golf course contains large stands of little bluestem, panic grass, tumble grass, and bush clover. Many weeds exist in this remnant, including Kentucky bluegrass, Canada bluegrass, grape woodbine, and common yarrow. Woody invasion is also occurring here, including sumac, black cherry, boxelder, and Siberian elm.

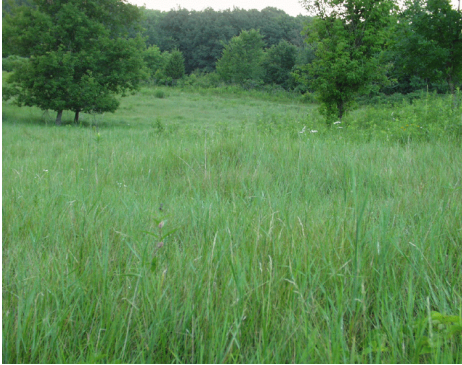
As opposed to a monotypic plant structure (limited diversity), restoring native prairies can reintroduce diverse systems that offer color, contrast, biodiversity, and habitat to the site.

Most of the park’s prairie systems have suffered degradation by following one of two pathways: either the absence of fire and other natural disturbances has resulted in woody invasion, which shades and out-competes most native prairie species, or the prairies were previously cropped. The first scenario of woody invasion is typified by sparse native prairie grasses and forbs with an increasing component of invasive woody species such as sumac, Siberian elm, black cherry, and boxelder. The second scenario of formerly cropped prairies generally results in old fields dominated by introduced naturalized grasses and forbs, many of which are typical weed species associated with disturbed landscapes (e.g., smooth brome, quack grass). Native plant species found in the old field settings are infrequent and typically are those that are most tolerant of disturbance. Most old fields within the park are also experiencing woody invasion.

In most cases, these prairie remnants can be restored to healthy native prairie systems.

In most cases, these prairie remnants can be restored to healthy native prairie systems. The appropriate combination of woody species removal, prescribed burning, and interseeding can often restore these prairies with moderate effort.

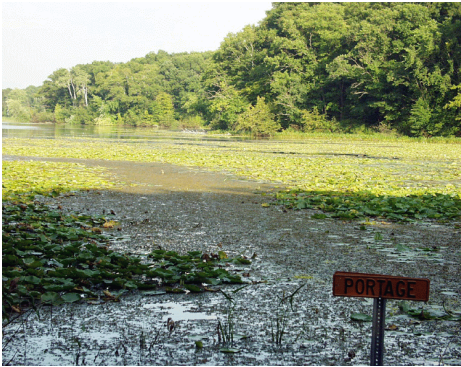
It appears that degradation of open water systems within the park is due primarily to the significant volumes and volatility of urban stormwater entering the park and the management of this stormwater.

One of the most critical factors associated with water quality and shoreline stability is maintaining a viable ecological buffer along the edge.

The quality of the lakes and ponds are being impacted greatly by stormwater management practices and sediment from unmanaged upland areas.

In particular at Lebanon Hills Regional Park, addressing stormwater before it enters the park boundaries is a key to successful restoration of open water and wetland systems.

In particular at Lebanon Hills Regional Park, addressing stormwater before it enters the park boundaries is a key to successful restoration of open water and wetland systems. Reduction or removal of these off-site stormwater inputs in conjunction with upland and wetland restoration efforts within the park should greatly increase water quality and enable more natural water levels to exist in the park's aquatic systems.

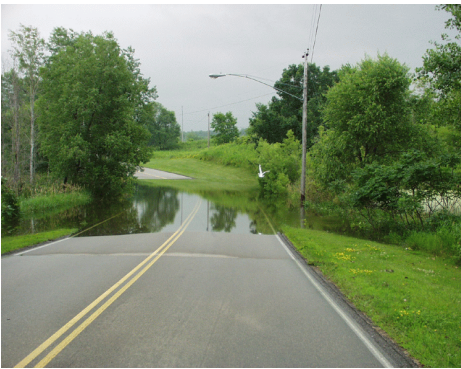
Entrance road to Schulze Lake is prone to flooding.

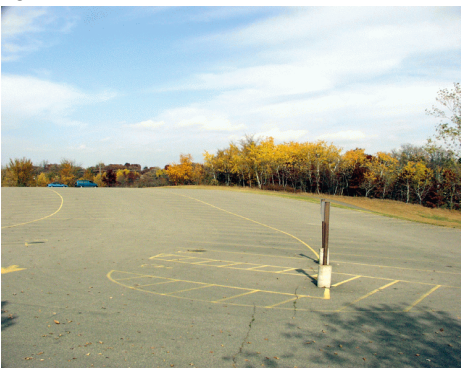
Large parking lot by Schulze Lake generates significant unchecked runoff.

In addition to trail-related conditions, other built factors contribute to ecological concerns in the park. As an example, the large parking lot near Schulze Lake generates a significant amount of unchecked water flow, which tends to aggravate stormwater management issues. Another example is the entrance road to this area that is built through a historic wetland and ponding area and is now prone to flooding. By paying more attention to the potential ecological impacts associated with development, future problems can be averted. The photos on the left highlight these examples.

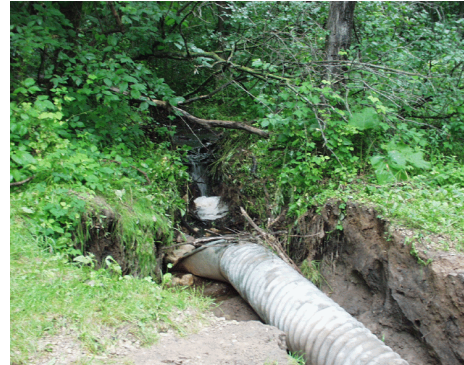
“Blowout” of a culvert after a major storm occurs when normal water flows are interrupted. Instead of a culvert, a short bridge crossing may prevent this from occurring in the future.

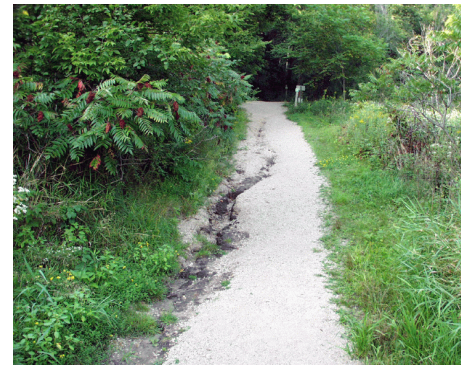
Trails that are steep and poorly placed tend to serve as the drainageway after a heavy storm, often leaving big eroded channels in the trail that require additional maintenance and cause sediment to flow into ponds and lakes.

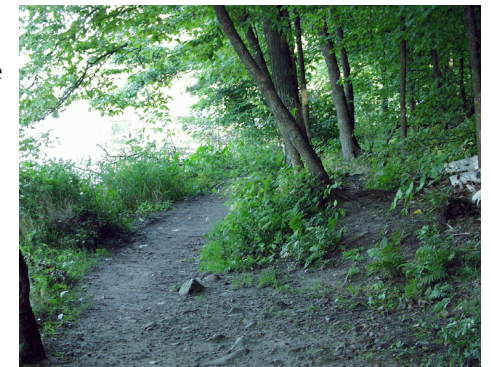
Trails creep is occurring to the right of the main trail around Jensen Lake. This happens when the trail bed is unstable during wet periods and people go off it to higher ground.

As the photo on the right illustrates, simple overuse of trails can cause ecological concerns. In these instances, a more stable trail bed will be needed to forestall continued degradation and “trail creep”.
